**Flood Control Project Maintenance
Levee Inspections**
LMA District Cover Sheet
Spring 2020 Levee Inspection Results

Reclamation District No. 0536 Egbert

Spring 2020 Levee Inspection Results

Waterway			Bank	Unit Miles
Unit No. 01 Lindsey Slough			Right	5.58
	Spring (March - May)	Summer (June - August)	(September - November) Fall	Winter (December - February)
Unit Maintenance Rating (Fall Only)				
Date of Inspection	4/15/2020 - 4/15/2020			
DWR Inspector	David Julian			
Accompanied By

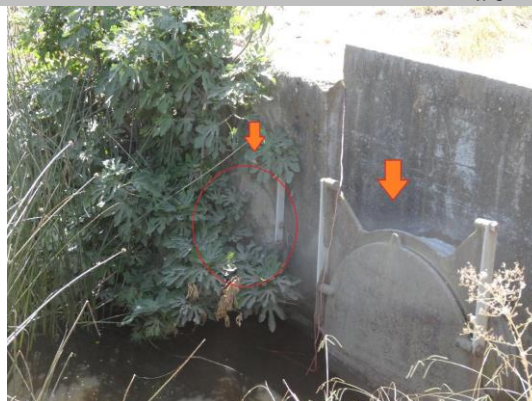
Photo 1 of 3 : UCIP_SP_2020_53359_34457.jpg

Comment Code						
Inspector Comment						
DS_ID:22712 FS_ID:53359 EP_NO: 10114 Repair Type: Urgent Crossing Status: Found UCIP Comments: 10/2/2018 Holes present in pipe pose internal levee threat; keeping as Urgent (D. Sanoski - DWR UCIP).06/01/2016: Holes and heavy corrosion inside pipe on WS have gotten worse. Flapgates appear in good condition though vegetation blocks view of flapgate for 36-inch on WS. These pipes are still in use and necessary for drainage; pipes may be eligible for repair under DWR Deferred Maintenance Program. (K. Fazel - UCIP)08/13/2013:- Holes in pipe outlet due to heavy corrosion.- Needs detailed investigation of the pipe.- Headwall cracked and tilted on WS. (P. Amatya - DWR) FIELD_STRUCT_DESC: 1 of 2: 60-inch corrugated metal gravity drainage pipe through the levee, 10 feet below the crown. Flap gate on the waterside (WS). Headwall on each end. Culverts run under the road to provide drainage from agricultural fields via a landside (LS) ditch to Lindsey Slough. No. 100 gate in the LS drainage ditch. Reclamation District No. 536 (RD0536) president is David Hearn at hearnd5@gmail.com. (Retention of one 60-inch and one 36-inch drainage pipes through the levee, 10 feet and 6.5 feet below the crown, respectively, and flap gates on the WS ends authorized under Automatic Board Order (ABO) issued as Permit No. 10114, 1974 - H. E. Peterson). [Additional Reference(s): DWR Levee Log, 1992. USACE Sacramento O&M Manual 106, May 1953, (Station 294+49 ""A""), invert elevation 14.4 feet]. FS Date: 10/2/2018 1:53:00 PM

WS view: two CMPs with flap gates. Concrete headwall supports the pipes. A 36" CMP (left) and 60" CMP (right).

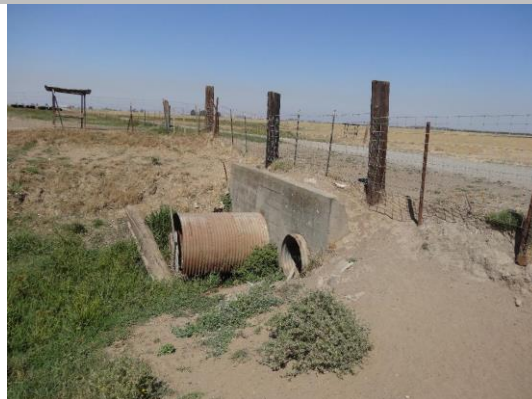
Photo 2 of 3 : UCIP_SP_2020_53359_34456.jpg

LS view: two inlet CMPs with flap gates. Concrete headwall supports the pipes. A 36" CMP (right) and 60" CMP (left).

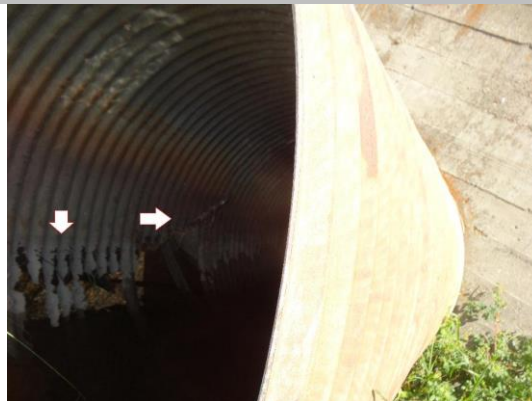
Photo 3 of 3 : UCIP_SP_2020_53359_34455.jpg

LS view: holes & cracks on CM pipe due to heavy corrosion. Needs detailed investigation of the pipe.

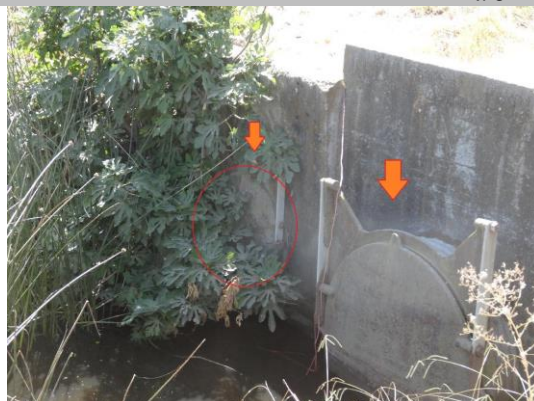
Photo 1 of 3 : UCIP_SP_2020_53360_34771.jpg

DS_ID:22726
FS_ID:53360
EP_NO: 10114
Repair Type: Urgent
Crossing Status: Found
UCIP Comments: 10/2/2018 Vegetation blocked WS view of pipe, though a hole directly above WS inlet pipe could be a sinkhole. Keeping as Urgent and recommend internal inspection due to holes in 60-inch pipe (D. Sanoski - DWR UCIP).06/01/2016 Pipe is not abandoned. Though neglected, it is still functional and a needed system feature. Pipe is severely corroded with holes in it, which are visible on LS. Vegetation blocks view of flapgate on WS. Pipes may be eligible for repair under DWR Deferred Maintenance Program. (K. Fazel - UCIP)08/13/2013 This pipe seems to be abandoned. Headwall cracked and tilted on WS. (P. Amatya)
FIELD_STRUCT_DESC: 2 of 2: 36-inch corrugated metal gravity drainage pipe through the levee, 10 feet below the crown. Flap gate on the waterside (WS). Headwall on each end. Culverts run under the road to provide drainage from agricultural fields via a landside (LS) ditch to Lindsey Slough. No. 100 gate in the LS drainage ditch. Reclamation District No. 536 (RD0536) president is David Hearn at hearnd5@gmail.com. (Retention of one 60-inch and one 36-inch drainage pipes through the levee, 10 feet and 6.5 feet below the crown, respectively, and flap gates on the WS ends authorized under Automatic Board Order (ABO) issued as Permit No. 10114, 1974 - H. E. Peterson). [Additional Reference(s): DWR Levee Log, 1992, referenced as 6.5 feet below the crown. USACE Sacramento O&M Manual 106, May 1953, (Station 294+49 ""A""), invert elevation 14.4 feet].

WS view: concrete headwall, flap gates on 36" CMP (left) and 60" CMP (right)

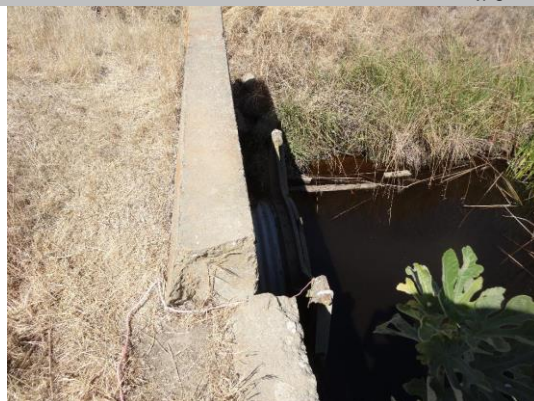
Photo 2 of 3 : UCIP_SP_2020_53360_34770.jpg

WS view: cracked and tilted concrete headwall.

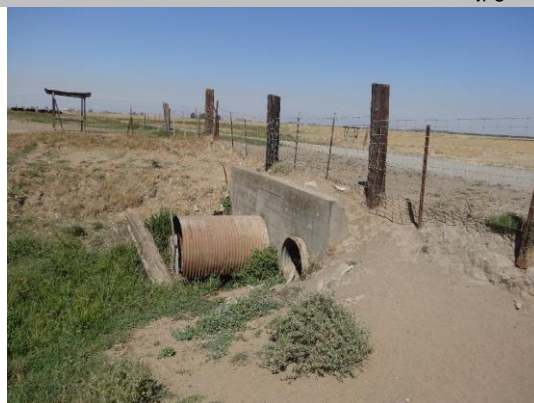
Photo 3 of 3 : UCIP_SP_2020_53360_34769.jpg

LS view: concrete headwall, 36" CMP (right) and 60" CMP (left)

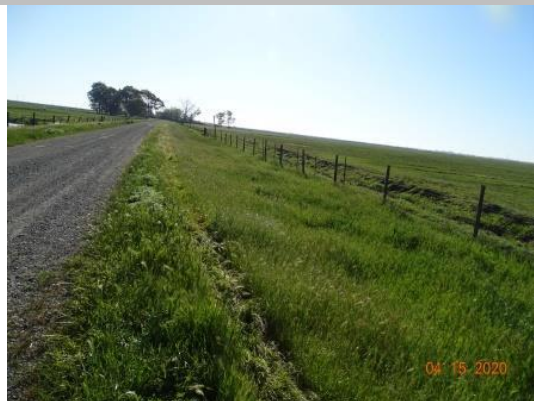
Photo 1 of 1 : SP_2020_RD0536_208_19_20200415_00061.jpg

LM Start	0.02	Rating **	M	Issue No.	19
LM End	1.76	Issue Type +	Ma	Location *	LS
Category	Earthen Levee			GPS Latitude/Longitude	
				Start	End
Item	Vegetation			38.244981 °	38.259695 °
				-121.768504 °	-121.750109 °
DWR ID	DWR_RD0536_01_s_2020_19				
Comment Code					
V1 : Control annual grass and weeds on the levee slopes and easements.					
Inspector Comment

View looking downstream at annual vegetation on the landside slope (Spring 2020).

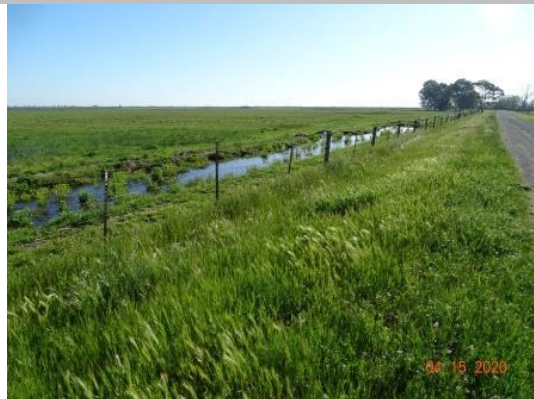
Photo 1 of 1 : SP_2020_RD0536_208_21_20200415_00060.jpg

View looking downstream at annual vegetation on the waterside slope (Spring 2020).

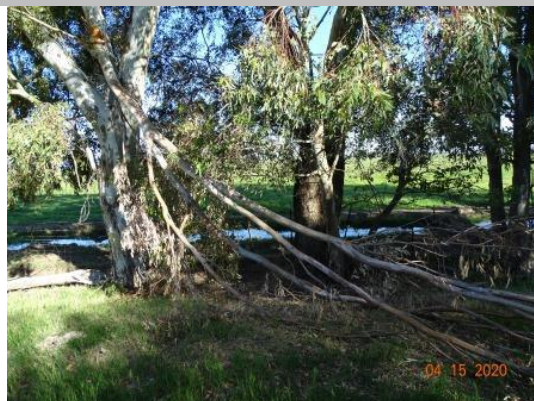
Photo 1 of 1 : SP_2020_RD0536_208_24_20200415_00062.jpg

LM Start	0.23	Rating **	M	Issue No.	24
LM End	0.23	Issue Type +	Ma	Location *	WS
Category	Earthen Levee			GPS Latitude/Longitude	
				Start	End
Item	Encroachments			38.245311 °	38.245311 °
				-121.764788 °	-121.764788 °
DWR ID	DWR_RD0536_01_s_2020_24				
Comment Code					
TR : Tree or limb					
Inspector Comment					
Remove down branch on waterside slope.

View of down tree branch on the waterside slope (Spring 2020).

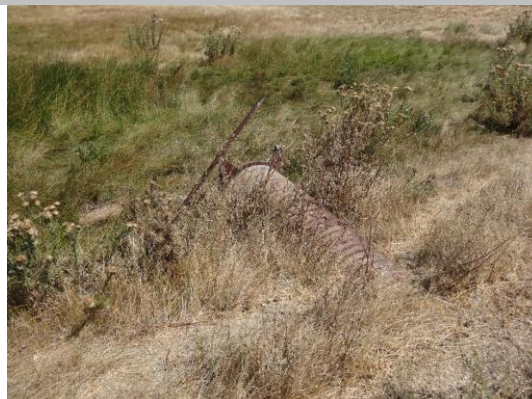
Photo 1 of 3 : UCIP_SP_2020_49313_34774.jpg

DS_ID:22713
FS_ID:49313
EP_NO: 10114
Repair Type: No Action Needed
Crossing Status: Found
UCIP Comments: 06/01/2016 Debris cleared and flapgate is no longer blocked. 08/13/2013 Outlet was blocked by concrete debris and dirt. Needs cleaning of debris.
FIELD_STRUCT_DESC: 24-inch corrugated metal gravity drainage pipe through the levee, 10.5 feet below the crown. Flap gate on the waterside (WS) end. Headwall on each end, not found in 2013 or 2016. No. 100 gate on the WS. Concrete debris on the WS slope. This crossing is also used for irrigation. 1-inch polyvinyl chloride (PVC) pipe sleeved through the 24-inch pipe, visible through the landside (LS) end. According to David Hearn, Reclamation District No. 536 (RD0536) president, the PVC pipe does not connect all the way through. Present landowner, as of 2016, is Solano Land Trust, and the pipe runs through the Jepson Prairie Reserve, managed by the University of California, Davis, (UC Davis). (Retention of a 24-inch drainage pipe through the levee, 10.5 feet below the crown, and a flap gate on the WS end authorized under Automatic Board Order (ABO) issued as Permit No. 10114, 1974 - H. E. Peterson). [Additional Reference(s): DWR Levee Log, 1992. USACE Sacramento O&M Manual 106, May 1953, (Station 274+00 "'A'"), invert elevation 15.8 feet].

WS view: overview of exposed CM pipe on levee slope.

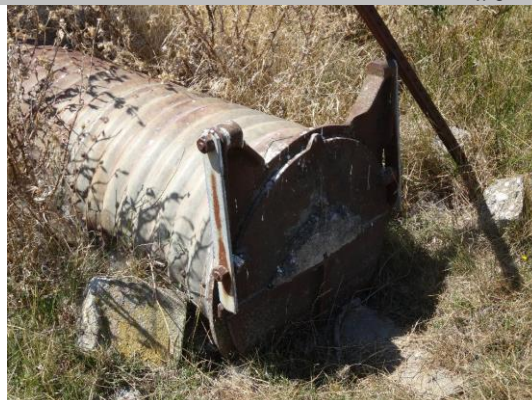
Photo 2 of 3 : UCIP_SP_2020_49313_34773.jpg

WS view: CM pipe blocked by concrete debris on levee slope.

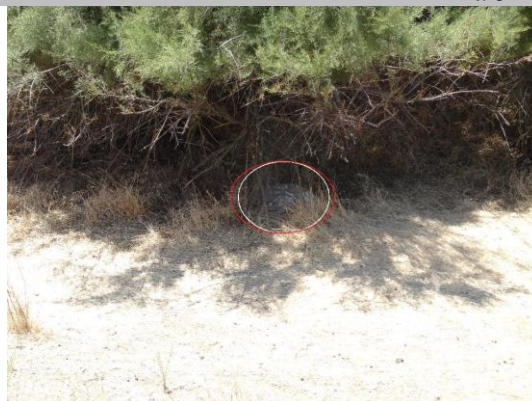
Photo 3 of 3 : UCIP_SP_2020_49313_34772.jpg

LS view: open CM pipe end on levee slope.

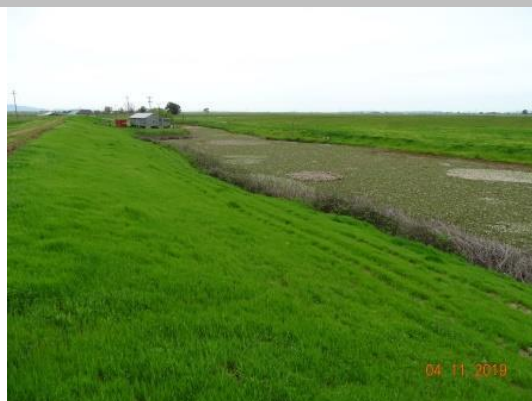
Photo 1 of 2 : SP_2020_RD0536_208_14_20200304_00002.jpg

LM Start	0.34	Rating **	M	Issue No.	30
LM End	0.34	Issue Type +	Ma	Location *	CR
Category	Earthen Levee			GPS Latitude/Longitude	
				Start	End
Item	Crown Surface / Depressions / Rutting			38.245615 °	38.245615 °
				-121.762820 °	-121.762820 °
DWR ID	DWR_RD0536_01_s_2020_30				
Comment Code					
C2 : Repair depressions or ruts in the crown or slope.					
Inspector Comment

View looking upstream at cow ruts on the waterside slope (Spring 2019).

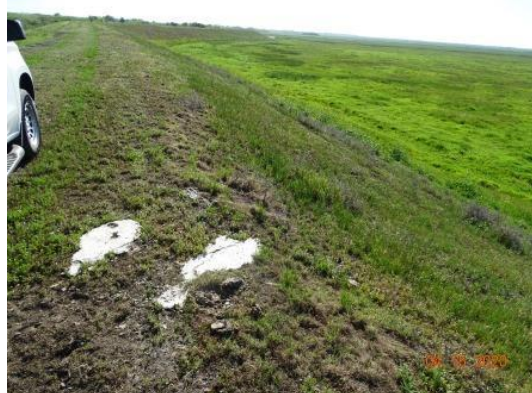
Photo 1 of 1 : SP_2020_RD0536_208_34_20200415_00063.jpg

LM Start	1.35	Rating **	M	Issue No.	34
LM End	1.35	Issue Type +	Ma	Location *	LS
Category	Earthen Levee			GPS Latitude/Longitude	
				Start	End
Item	Slope Stability			38.258927 °	38.258927 °
				-121.756932 °	-121.756932 °
DWR ID	DWR_RD0536_01_s_2020_34				
Comment Code					
S1 : Repair slope instability.					
Inspector Comment					
Dip in the roadway and slope on the landside.

View of dip in the crown and slope on the landside (Spring 2020).

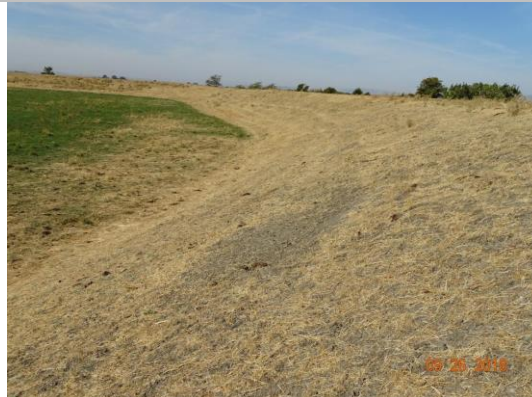
Photo 1 of 1 : SP_2020_RD0536_208_17_20200304_00006.jpg

LM Start	1.45	Rating **	M	Issue No.	17
LM End	1.45	Issue Type +	Ma	Location *	LS
Category	Earthen Levee			GPS Latitude/Longitude	
				Start	End
Item	Slope Stability			38.259087 °	38.259087 °
				-121.755133 °	-121.755133 °
DWR ID	DWR_RD0536_01_f_2018_17				
Comment Code					
S2 : Repair the levee slope damaged by foot traffic and prevent access where possible.					
Inspector Comment					
Depressions in levee due to cows should be repaired to prevent deeper depressions into levee.

View looking upstream at divots in the slope created by cows. Divots are deep enough that they should be corrected (September 2018).

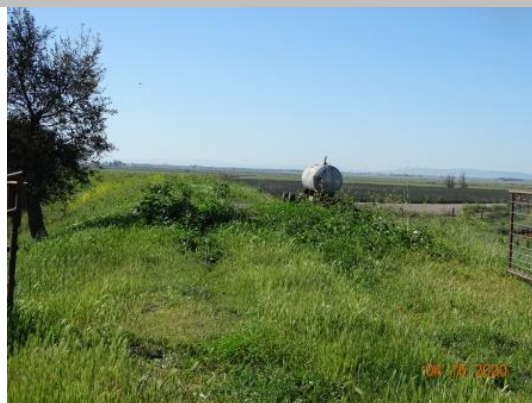
Photo 1 of 1 : SP_2020_RD0536_208_31_20200415_00064.jpg

View looking downstream at vegetation on the crown (Spring 2020).

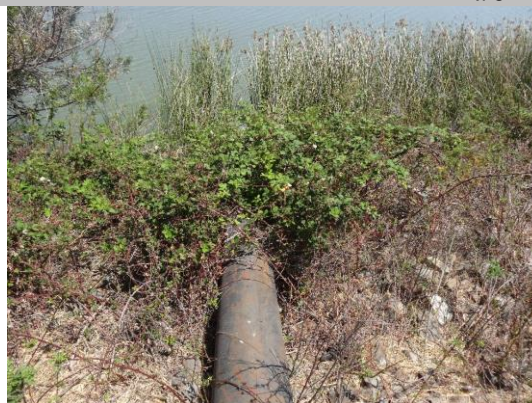
Photo 1 of 3 : UCIP_SP_2020_49314_34789.jpg

Comment Code						
Inspector Comment						
DS_ID:24023 FS_ID:49314 EP_NO: N/A Repair Type: Non-Urgent Crossing Status: Found UCIP Comments: 06/01/2016 Could not see flapgate in water. Pipes still in use. No cover over pressure relief valve on WS slope.08/13/2013:- Field discovered pipe.- Needs more information from the LMA/ DWR Inspector. - Dense vegetation on WS.- Pump feeds both pipes. FIELD_STRUCT_DESC: 2 of 2: 18-inch steel drainage discharge pipe through the levee, approximately 4 feet below the crown. Pump, called the Buddha Pump, in a pump house on the landside (LS) at the drainage ditch. Pressure breaker on the waterside (WS) slope. Pump and pipes are used by Reclamation District No. 536 (RD0536), per district president David Hearn, but could not identify permit information. Landowner is Dan Hearn per Solano County Assessor's Office (Parcel No. 0042-180-220). FS Date: 6/1/2016

WS view: exposed 18" steel pipe on levee slope.

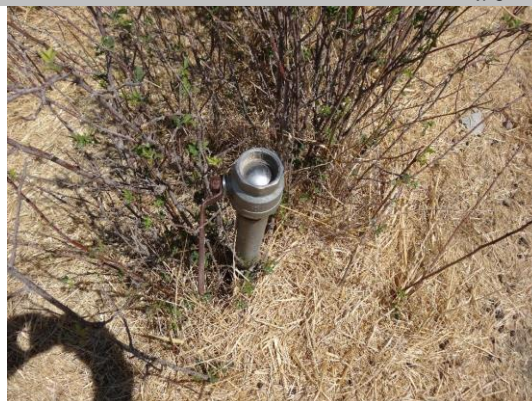
Photo 2 of 3 : UCIP_SP_2020_49314_34788.jpg

WS view: pressure breaker/valve on levee slope.

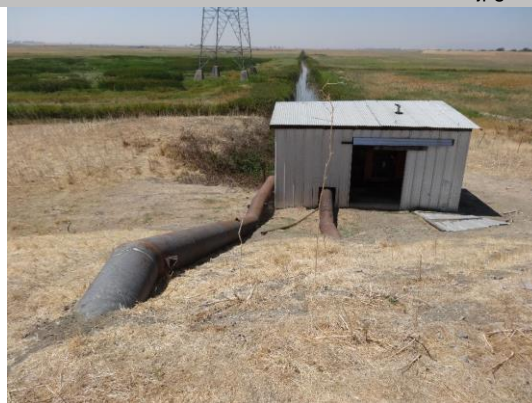
Photo 3 of 3 : UCIP_SP_2020_49314_34787.jpg

WS view: exposed 18" steel pipe (left) and 16" steel pipe (right) on levee slope. Pump house on bank of drainage ditch.

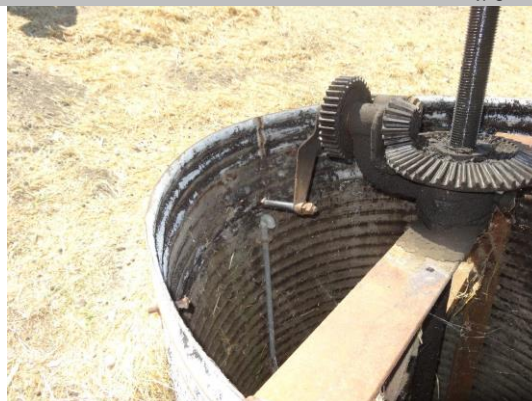
Photo 3 of 3 : UCIP_SP_2020_20503_34566.jpg

WS view: closer view of slide gate in CMP riser on levee slope. Air vent attached to the wall of CMP (left).

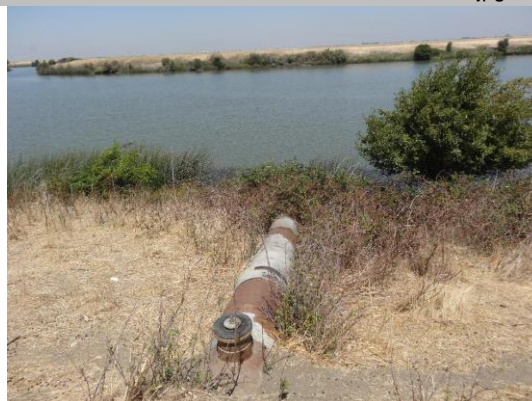
Photo 1 of 3 : UCIP_SP_2020_49317_34579.jpg

UCIP Comments: 06/01/2016 New pump recently installed. Flapgate not visible though not required under condition of Permit No. 2131. No positive closure device found, which, if missing, is a violation of Condition 8 of Permit No. 2131. Need a name change permit for new owner RD0536. Siphon breaker missing cover.08/13/2013 Pump is missing at the time of inspection. May be taken out for repair.Flapp gate on waterward end not found/visible as pipe was submerged into water.Pipe itself is a walkway with steel handrail.

WS view: exposed steel pipe with siphon breaker on levee slope.

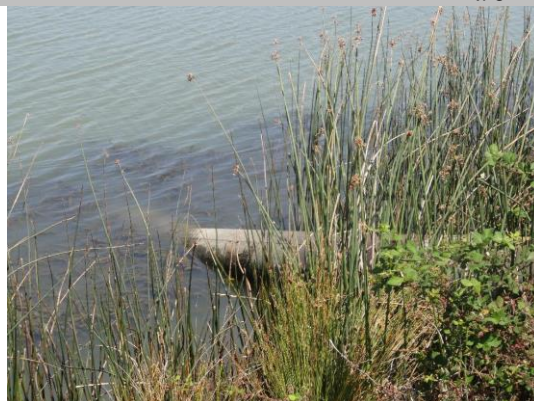
Photo 2 of 3 : UCIP_SP_2020_49317_34578.jpg

WS view: steel pipe submerged into water in the stream.

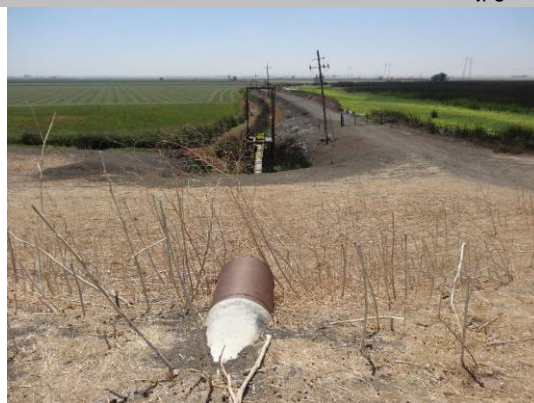
Photo 3 of 3 : UCIP_SP_2020_49317_34577.jpg

LS view: exposed steel pipe on levee slope and pump deck in drainage ditch.

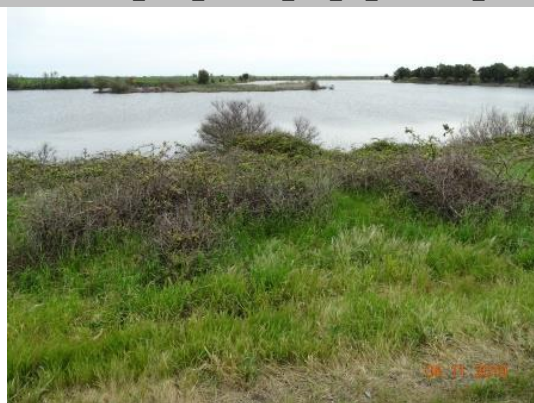
Photo 1 of 1 : SP_2020_RD0536_208_42_20200304_00019.jpg

View looking downslope at blackberries on the waterside slope (Spring 2019).

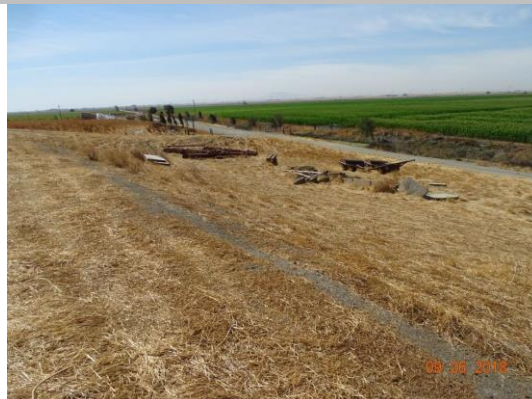
Photo 1 of 1 : SP_2020_RD0536_208_23_20200304_00011.jpg

View looking down slope of farm equipment on the landside slope (September 2018).

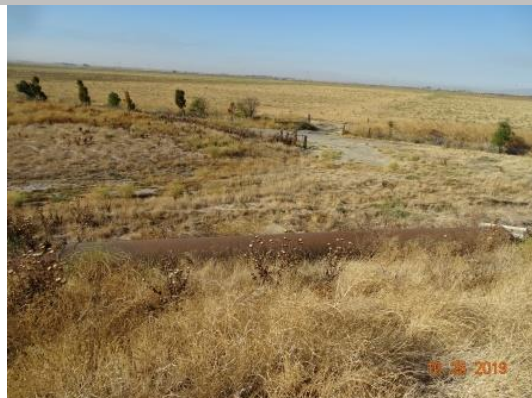
Photo 1 of 1 : SP_2020_RD0536_208_52_20200304_00024.jpg

View of large discarded pipe at the landside toe (Fall 2019).

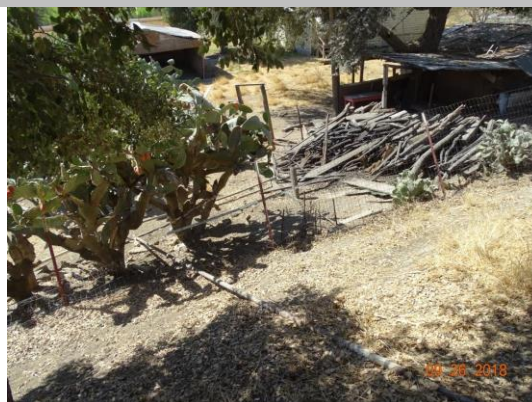
Photo 1 of 1 : SP_2020_RD0536_208_25_20200304_00013.jpg

Cactus, fence, and wood piles at the landside toe (September 2018).

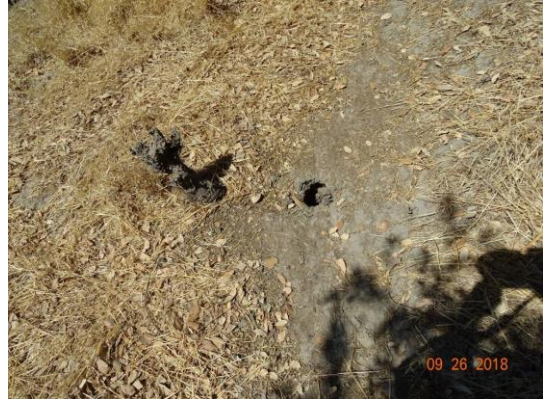
Photo 1 of 1 : SP_2020_RD0536_208_26_20200304_00014.jpg

View of squirrel hole on the landside slope (September 2018).

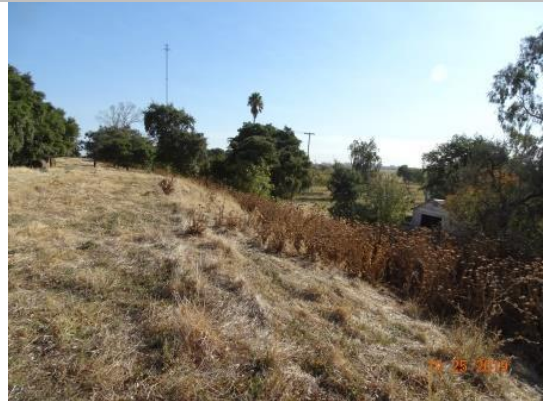
Photo 1 of 1 : SP_2020_RD0536_208_54_20200304_00025.jpg

View looking downstream at vegetation on the landside slope (Fall 2019).

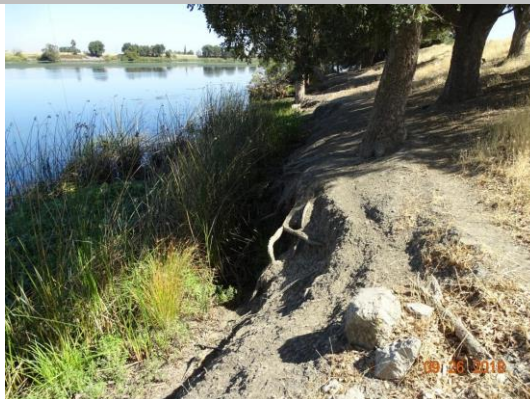
Photo 1 of 1 : SP_2020_RD0536_208_16_20200304_00005.jpg

LM Start	4.94	Rating **	M	Issue No.	16
LM End	4.95	Issue Type +	Ma	Location *	WS
Category	Supplemental			GPS Latitude/Longitude	
				Start	End
Item	2017 USACE Erosion Survey			38.245581 °	38.245667 °
				-121.708605 °	-121.708327 °
DWR ID	DWR_RD0536_01_f_2018_16				
Comment Code					
Inspector Comment					
2017 Site ID: LDS 0.8 R					
Status: Eroding					
2017 Field Notes: additional erosion at toe.					
Site History: 2011 - Multiple erosion pockets from tree popouts. A smaller erosion pocket in the middle of a failing bank repair. Pump structure at the downstream end may be contributing to the erosion.

Deeper erosion at the toe with roots exposed (September 2018).

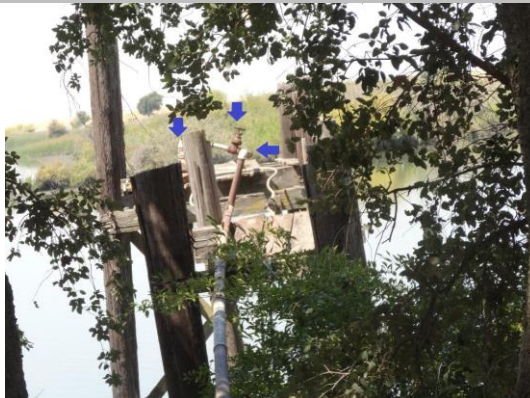
Photo 1 of 3 : UCIP_SP_2020_49318_34605.jpg

Comment Code					
Inspector Comment					
DS_ID:22720 FS_ID:49318 EP_NO: 10116 Repair Type: Non-Urgent Crossing Status: Found UCIP Comments: 06/01/2016 Pipe is an abandoned crossing per conversation with district president David Hearn.Pipe seems to be abandoned.Catwalk and pumphouse on riverside not found. It is not clear whether the pipe pass through the levee or not. Needs more info from LMA/DWR Inspector. FIELD_STRUCT_DESC: 3-inch galvanized irrigation discharge pipe through the levee, 4 feet below the crown. Catwalk and pump house on the waterside (WS). Concrete saddle and water tank on the WS slope. (Retention of a 3.5-inch pipe through the levee, 4 feet below the crown, concrete saddle, and water tank on the WS slope authorized under Automatic Board Order (ABO) issued as Permit No. 10116, 1974 - Marion Sanchez Farms). [Additional Reference(s): DWR Levee Log, 1992. USACE Sacramento O&M Manual 106, May 1953, (Station 33+16 ""R""), invert elevation 19 feet]. FS Date: 8/13/2013

WS view: pump, pipe, gate valve, and wooden piling structure in the stream.

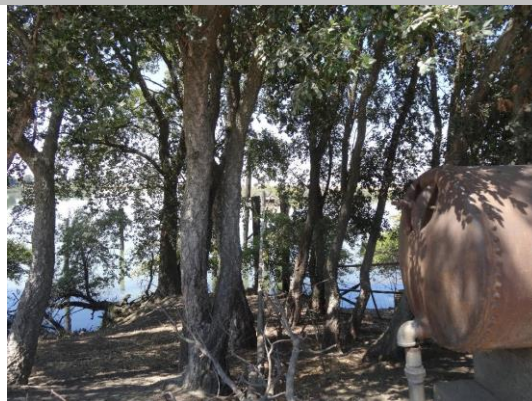
Photo 3 of 3 : UCIP_SP_2020_49318_34603.jpg

WS view: concrete cradle and abandoned steel tank on levee shoulder.

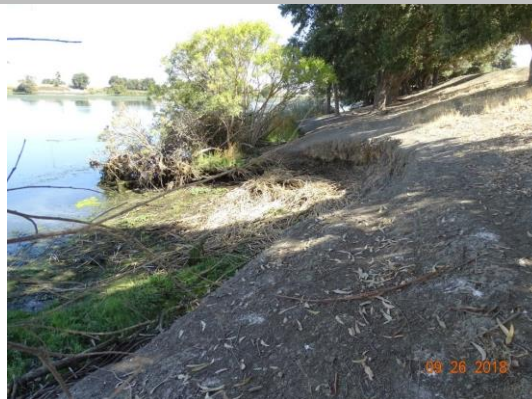
Photo 1 of 1 : SP_2020_RD0536_208_15_20200304_00004.jpg

Large erosion pocket on the waterside slope extends deep into slope (September 2018).

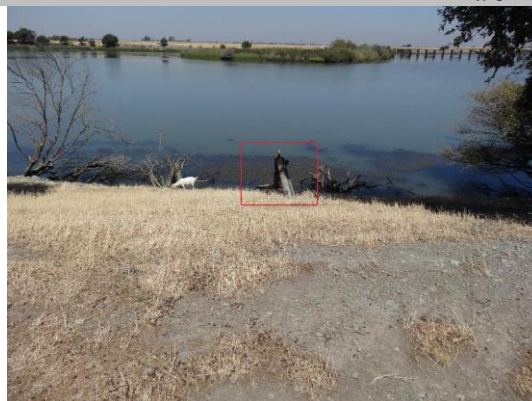
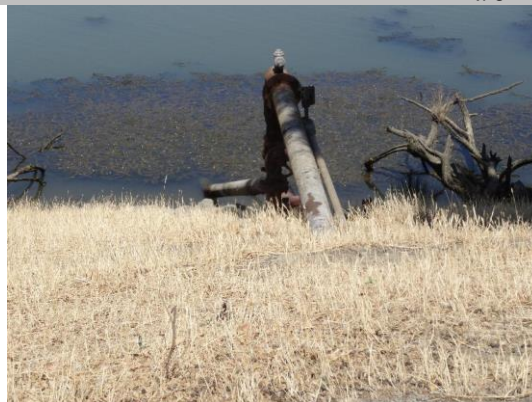
Comment Code						
Inspector Comment						
DS_ID:24664						
FS_ID:49319						
EP_NO: N/A						
Repair Type: Non-Urgent						
Crossing Status: Found						
UCIP Comments: 06/01/2016 According to district president David Hearn, landowner is Silva and crossing is abandoned.08/13/2013:Field discovered pipe crossing.Needs more information from LMA/DWR Inspector. Also needs more detailed inspection.						
FIELD_STRUCT_DESC: *ABANDONED* Approximately 6-inch steel irrigation discharge pipe and an electrical conduit through the levee, at an unknown depth. Slant pump in a steel support on the channel bank. Gate valve on the pipe. No pipes and appurtenances on the landside (LS). This crossing was field discovered.						
FS Date: 8/13/2013

WS view: pipe and pump on channel bank.

WS view: closer view of pipe and pump on channel bank.

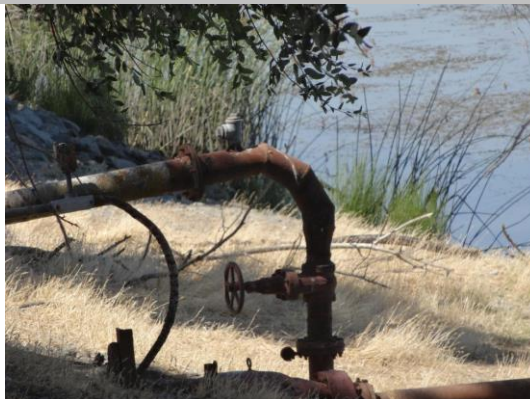
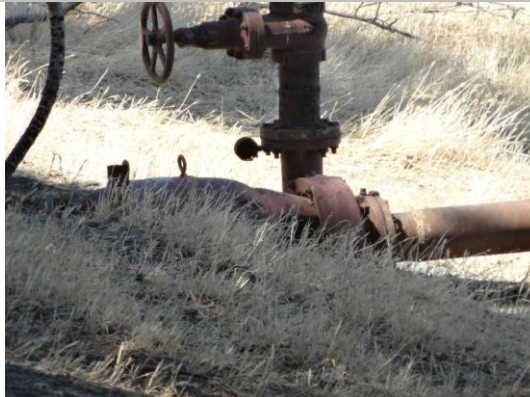
LM Start	5.10	Rating **	M	Issue No.	69	
LM End	5.10	Issue Type +	En	Location *		
Category	Supplemental			GPS Latitude/Longitude		
				Start		End
Item	DWR UCIP Field Study			38.245783 °		38.245783 °
				-121.705999 °		-121.705999 °
DWR ID	22721					
Comment Code						
Inspector Comment						
DS_ID:22721 FS_ID:20543 EP_NO: 3873 Repair Type: Non-Urgent Crossing Status: Found UCIP Comments: Pipe seems to be abandoned.Needs proper abandonment. FIELD_STRUCT_DESC: 6-inch irrigation discharge pipe of an unknown material through the levee, 2 feet below the crown. Pump on a concrete base on the waterside (WS) slope. Gate valve on the WS slope. (Plans for installation of a 6-inch pipe through the levee authorized under Permit No. 3873, 1962 - California Packing Corporation). [Additional Reference(s): DWR Levee Log, 1992]. FS Date: 8/13/2013

WS view: abandoned pipe, pump, conduit, and gate valve on levee slope.

WS view: closer view of abandoned pipe, pump, and gate valve on levee slope.

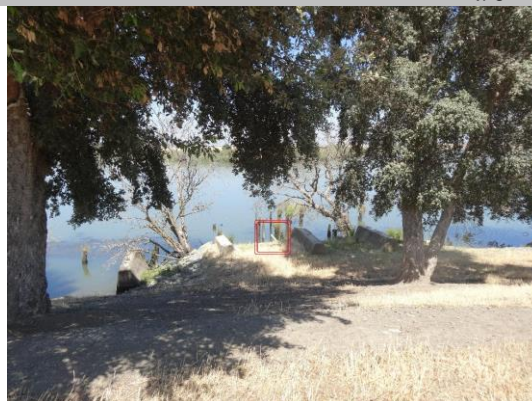
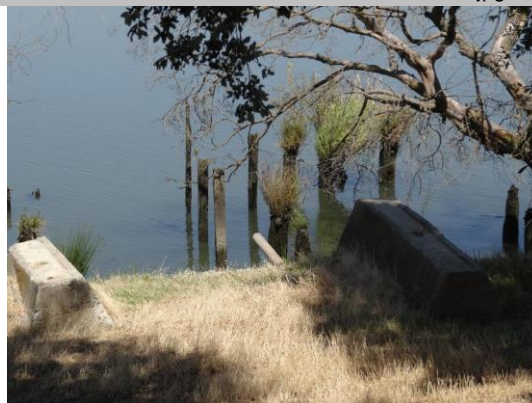
WS view: overview of levee slope, concrete pad, and pipe.

WS view: abandoned steel pipe on concrete pad.

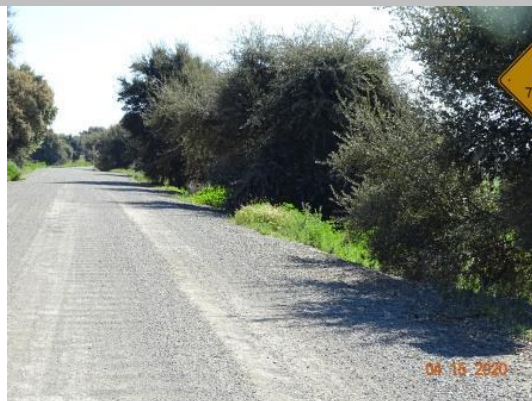
Photo 1 of 1 : SP_2020_RD0536_208_45_20200415_00066.jpg

View looking downstream at annual vegetation on the landside slope (Spring 2020).

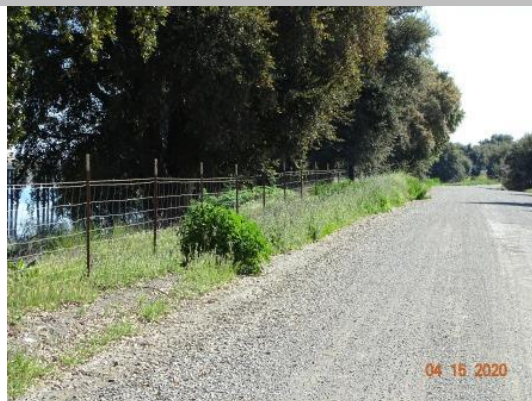
Photo 1 of 1 : SP_2020_RD0536_208_41_20200415_00065.jpg

View looking downstream at annual vegetation on the waterside slope (Spring 2020).

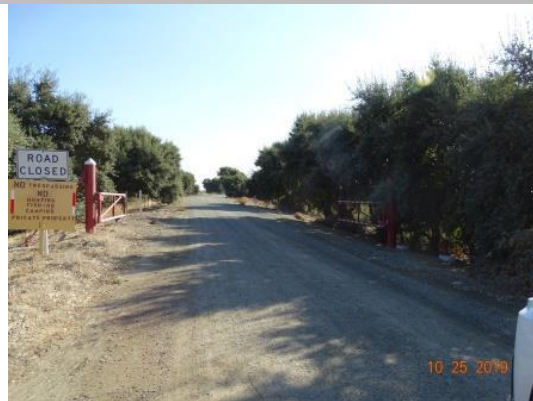
Photo 1 of 1 : SP_2020_RD0536_208_11_20200304_00001.jpg

View looking downstream at gate (Fall 2019).

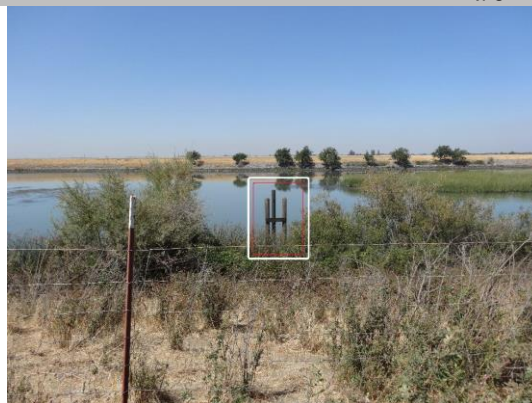
Photo 1 of 3 : UCIP_SP_2020_20563_34646.jpg

WS view: wooden & steel piles on the slough. Probably the supports are for pipe and flap gate. Not accessible due to fence.

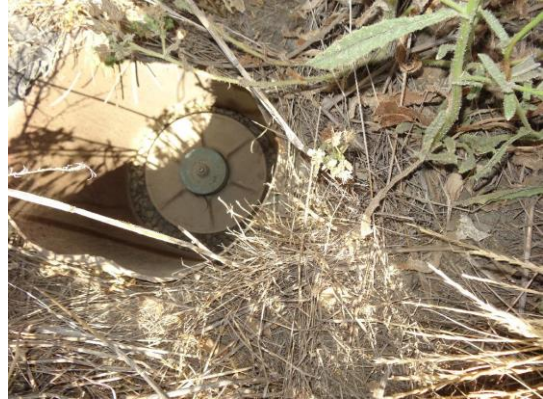
Photo 2 of 3 : UCIP_SP_2020_20563_34645.jpg

WS view: uncovered siphon breaker on levee shoulder. It needs protection.

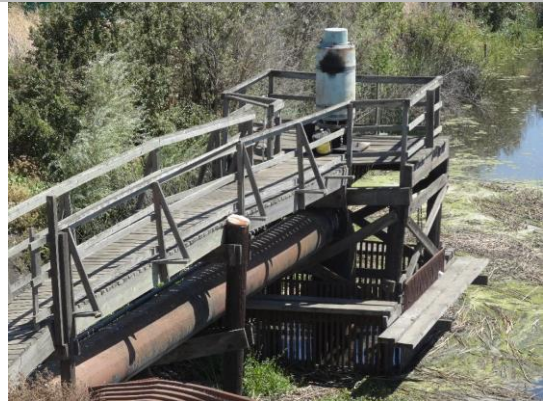
Photo 3 of 3 : UCIP_SP_2020_20563_34644.jpg

LS view: pipe under the wooden walkway and pump on wooden platform in drain ditch.

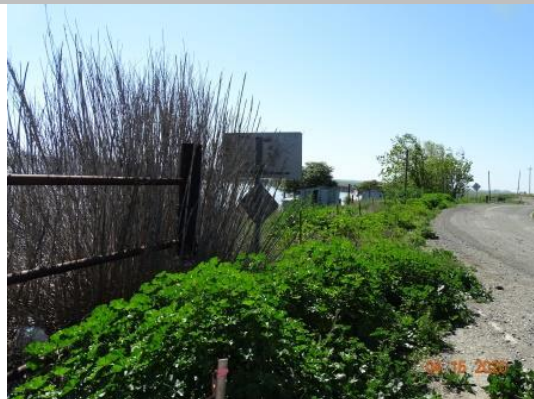
Photo 1 of 1 : SP_2020_RD0536_209_10_20200415_00023.jpg

View looking downstream at annual vegetation on the waterside slope (Spring 2020).

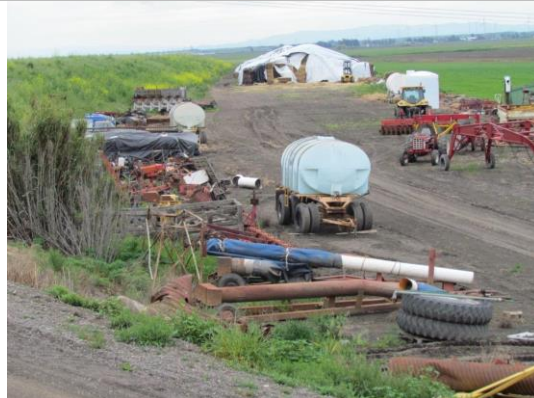
Photo 1 of 1 : SP_2020_RD0536_209_5_20200304_00001.jpg

View of equipment on the landside toe.

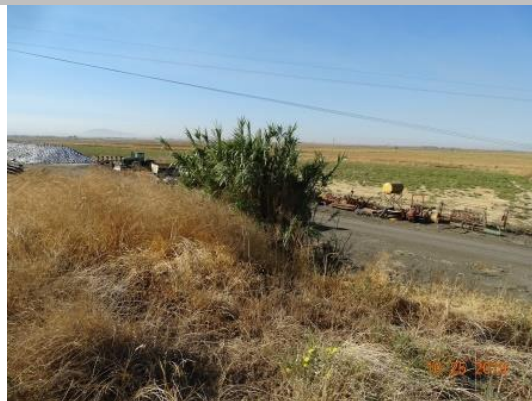
Photo 1 of 1 : SP_2020_RD0536_209_7_20200304_00003.jpg

View looking downslope at arundo on the landside slope (Fall 2019).

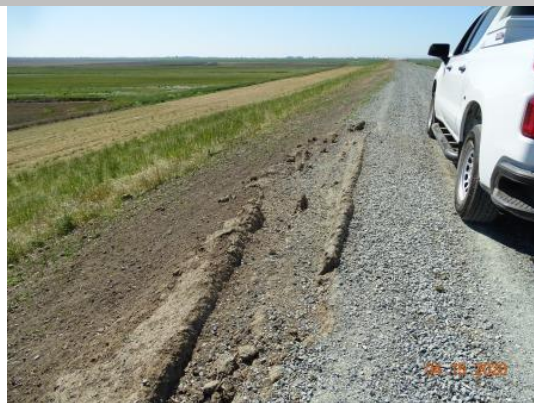
Photo 1 of 1 : SP_2020_RD0536_209_14_20200415_00024.jpg

View looking downstream at surface depression on the waterside hinge (Spring 2020).

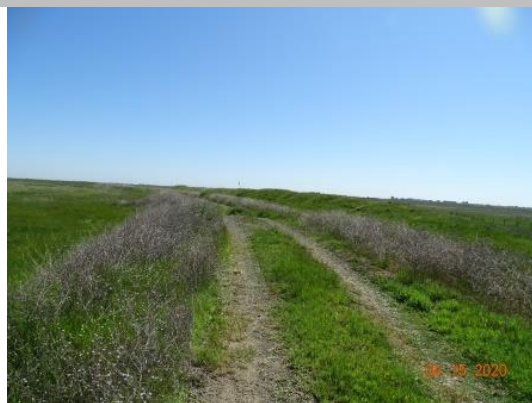
Photo 1 of 1 : SP_2020_RD0536_209_21_20200415_00026.jpg

View looking downstream at annual vegetation on the waterside slope (Spring 2020).

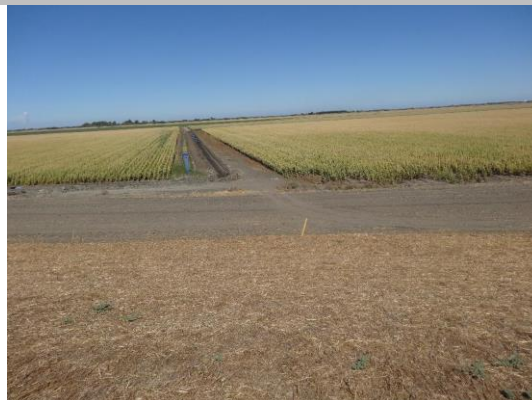
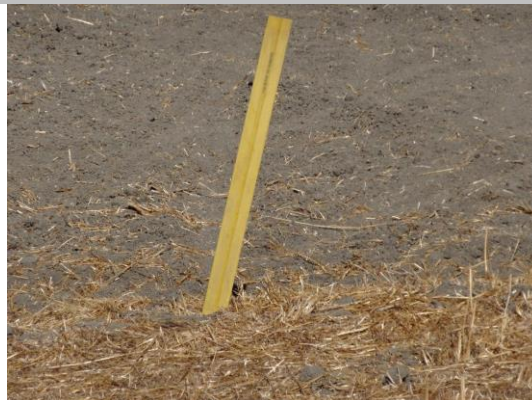
WS view: overview of levee slope and gasline indicator. The indicator is different than standard indicators.

WS view: closer look at gasline indicator. The indicator is different than standard indicators.

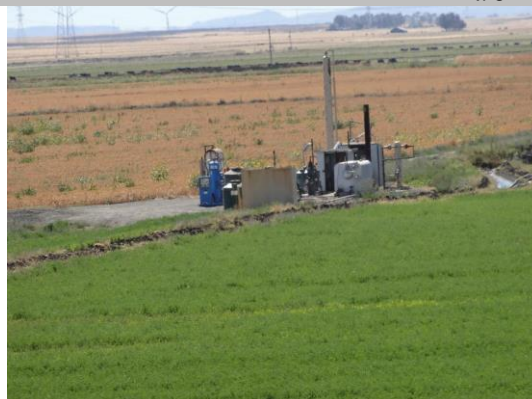
Photo 3 of 3 : UCIP_SP_2020_20664_34744.jpg

WS view: natural gas extraction plant near levee on the field.

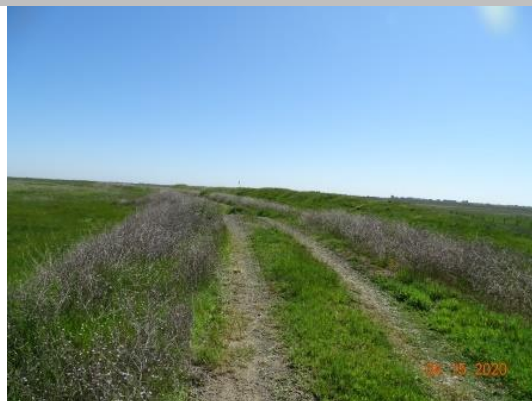
Photo 1 of 1 : SP_2020_RD0536_209_17_20200415_00025.jpg

View looking downstream at annual vegetation on the landside slope (Spring 2020).

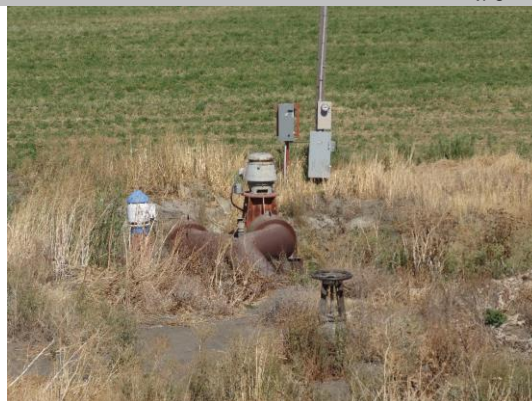
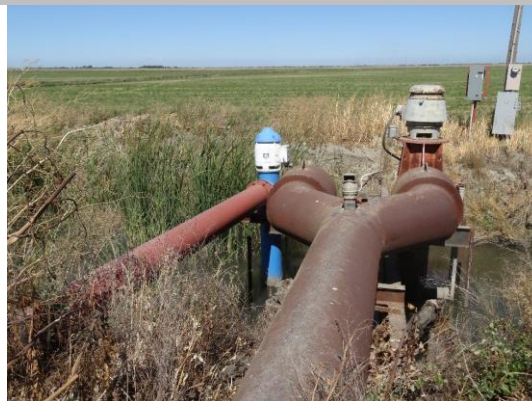
WS view: overview of pipe and pump (left). Big pump and appurtenances (right) for 24" steel pipe.

WS view: closer view of pipe and pump (left). Big pump and appurtenances (right) for 24" steel pipe.

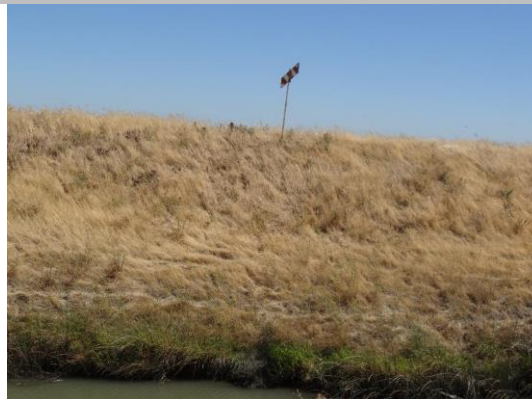
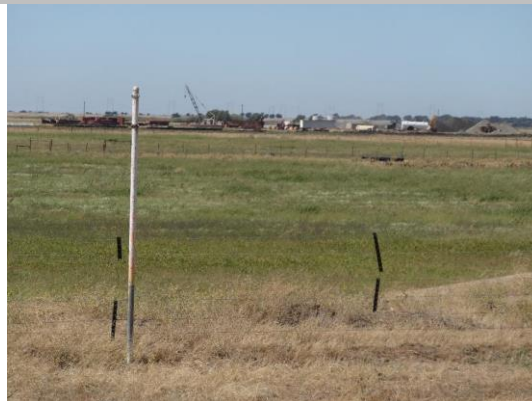
WS view: gasline indicator across the channel.

LS view: gasline indicator on levee toe.

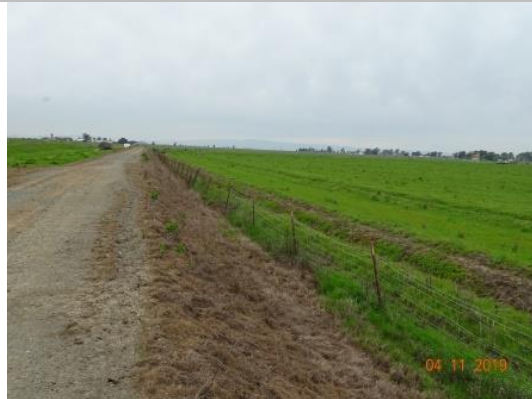
Photo 1 of 1 : SP_2020_RD0536_209_25_20200304_00011.jpg

View looking upstream at barbed wire fence at landside toe (Spring 2019).

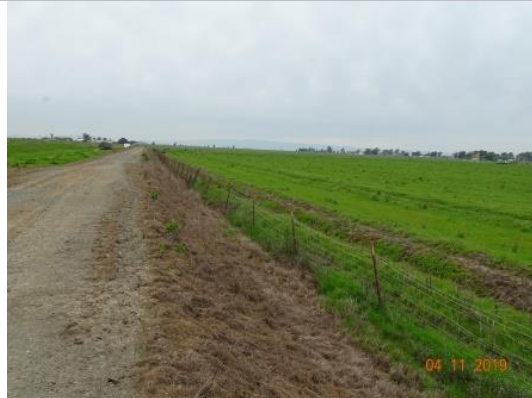
Photo 1 of 1 : SP_2020_RD0536_209_26_20200304_00012.jpg

View looking upstream at ditch on the landside toe (Spring 2019).

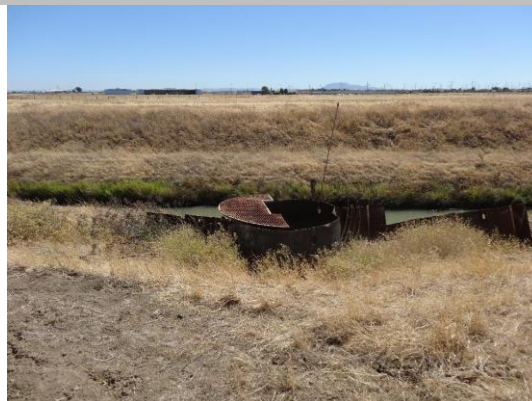
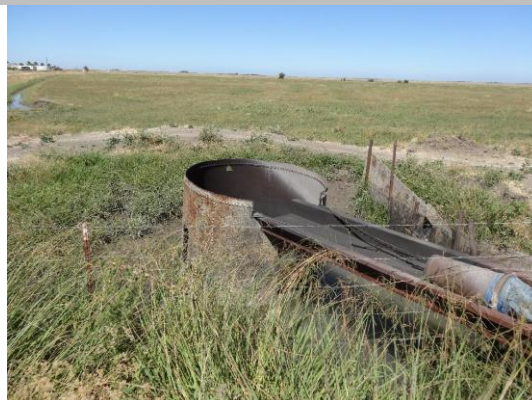
WS view: steel standpipe on levee slope.

LS view: steel standpipe on levee slope.

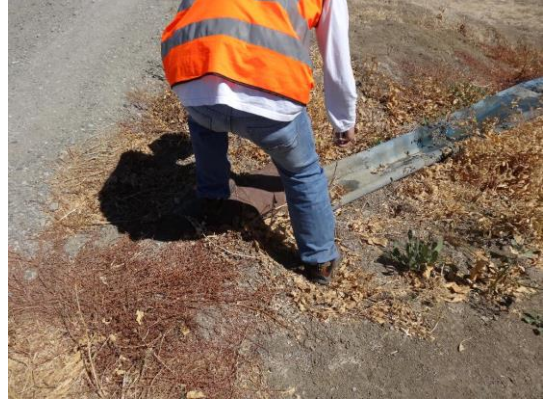
Photo 3 of 3 : UCIP_SP_2020_46813_34766.jpg

WS view: steel pipe on levee shoulder at 2-inch below the crown.
